ROOF RESTING LIFT & INVERTED DASH DISPLACEMENT

By Cris Pasto

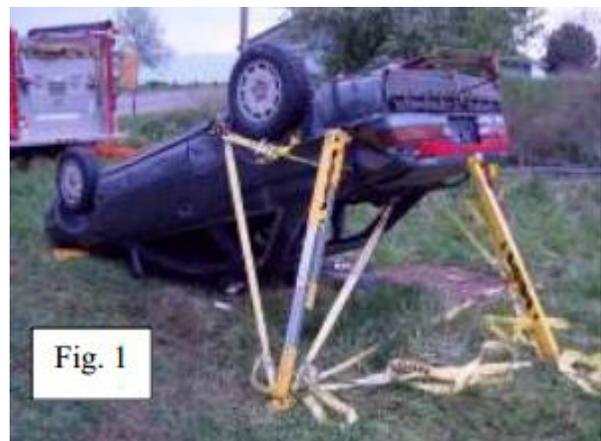
The solution to the support issue once the 'A'-post is cut is to have rear end stabilization in place prior to cutting. If space between the dash and ground is needed to allow the dash to displace, a rear lift of the vehicle will typically resolve this. Both of these issues can be resolved with the Res-Q-Jack® equipment where the techniques for roof resting stabilization and rear lift are employed.(Fig.1)
